# BELZONA UPGRADE TO LARGE TRANSFORMER

ID: 3090

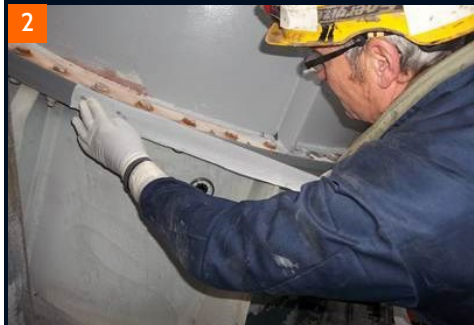
Oil was leaking from many of the flanges. Replacing the seals was not an option. This would have required draining the 42 tonnes of oil from the transformer as well as individually dismantling the 70 flange faces, a very time-consuming task.

1. Original condition of the flange faces
2. Repair with Belzona 1161 and Belzona 9341
3. Belzona being applied to encapsulate the bolts
4. Finished application.

Application was carried out in accordance with Belzona Know-How System Leaflet VPF-11a.. After the surface was prepared using an MBX Bristle Blaster followed by degreasing the substrate, Belzona® 1161 and Belzona® 9341 (Reinforcement tape) were applied onto the whole surface of the flange faces in order to stem the leaks.
