# BELZONA SEALS TRANSFORMER LID FLANGE

ID: 3091

Lid gasket flange on this 66-11Kv transformer.

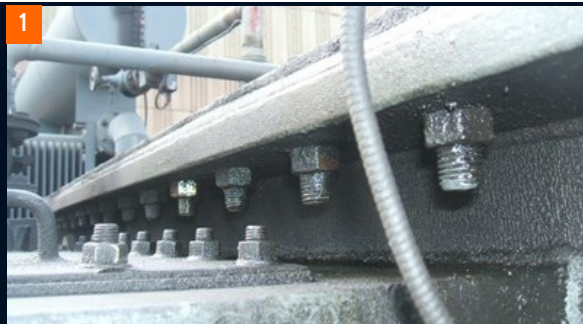
Most of the gasket had failed around the 10m perimeter of the lid, with oil seeping down the sides and going to ground. Unfortunately it was not possible to drain the oil below the gasket level and so the application had to be pursued as a live leak with a 1m head pressure.

1. Original condition of flange with header tank at rear
2. Encapsulation of bolts with Belzona 1161
3. Completed repair close up
4. Finished work after 3 days

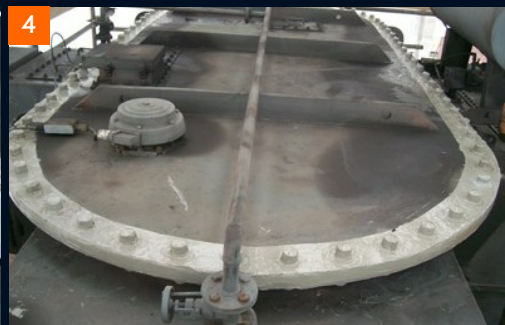
The customer was desperate for a fast solution to the problem and whilst there were a couple of very minor leaks still on completion, these were deemed to be well within acceptable limits. The customer was delighted with the results and is looking to repeat the application to other transformers on their site.
