# BELZONA IDEAL SOLUTION FOR DAMAGED CONVEYOR BELT

ID: 3125

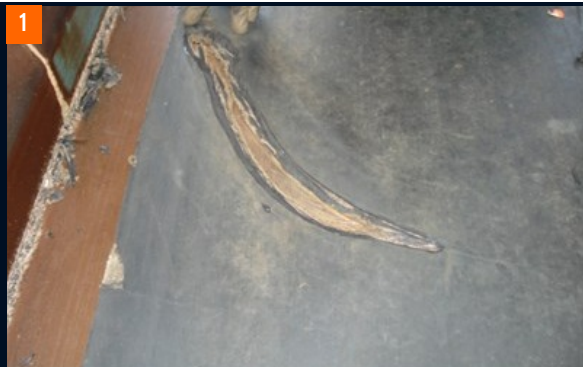
The fork lift driver caught the conveyor belt while he was loading the paper, stopping the process and tearing the belt.

1. Conveyor belt damage
2. Preparation and conditioning with Belzona 2911
3. Belzona 2311 being applied and incorporating Belzona 9341 (Reinforcement Tape)
4. Job done
