# BELZONA STOPS PREMATURE WEAR ON THIS RUBBER BELT

ID: 313

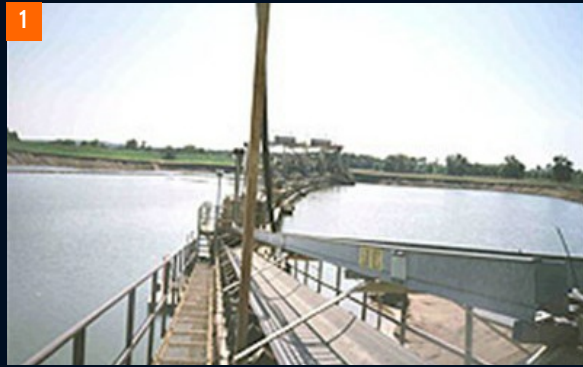
Gravel from the quarrying operation was wearing the clips out prematurely and creating unscheduled outages.

Conveyor belt clips from a dredger.
