# BELZONA DIESEL ENGINE BLOCK RESTORED

ID: 32

Hitachi diesel engine of a ship

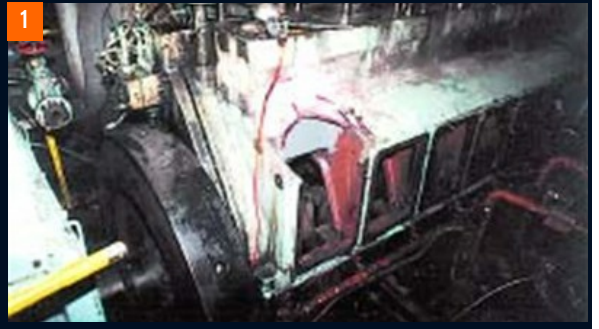
Connecting rod went through the side of the casing, severely damaging the engine block

Damaged engine block    In the engine room, work in progress    The finished repair
