# BELZONA SEALS GEARBOX DOORS TO ELIMINATE OIL LEAKS

ID: 332

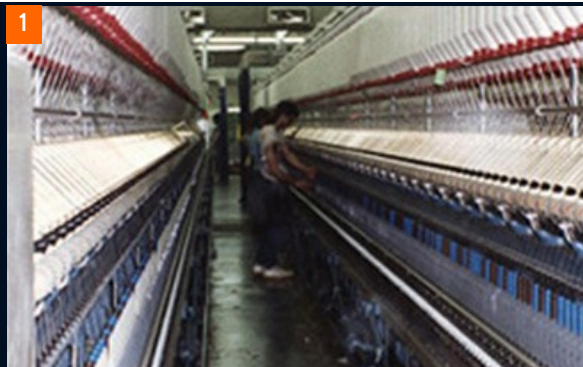
Oil leaks around seams and gearbox doors were causing safety problems at several locations where this equipment was in operation; including the Southeast U.S. and Japan.

1. A view of the loom in operation
2. Cutting gasket material away from seams
3. Applying Belzona 1211 (E-Metal) over the seams
4. Completed application around the bottom of the door below oil level
