# BELZONA'S ABS APPROVED PROCEDURE USED TO REPAIR PROPELLER BOLT HOLES

ID: 337

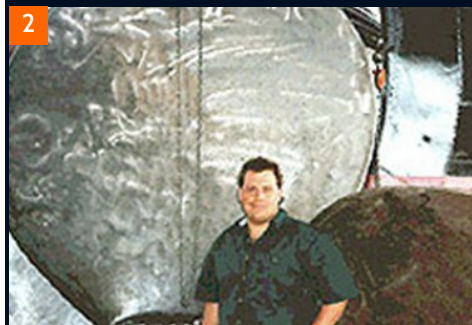
1. View of military sealift command vessel
2. View of the ships propeller
3. Applying Belzona 1111 (Super Metal) to the bolt holes
4. Finished applications being cured

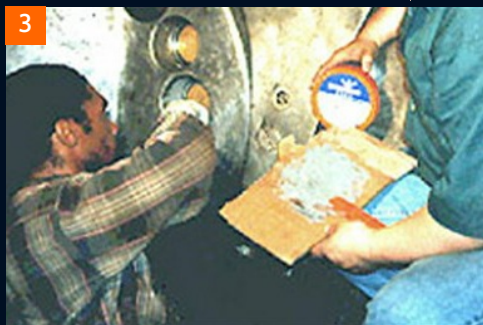
Excessive pitting on the propeller was due to a combination of crevice corrosion and general corrosion caused vibration and uneven distribution of load.
