# CAVITATION DAMAGE TO THIS TANKER PROPELLER REPAIRED WITH BELZONA

Cavitation damage to a 12-foot diameter tanker propeller.

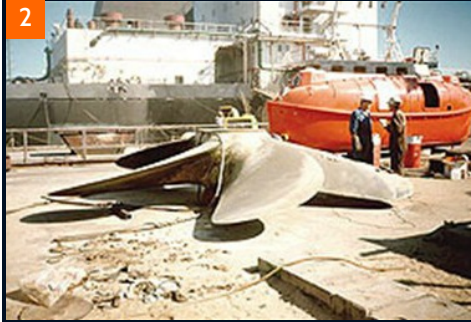
The large difference in pressure on the edges of this bronze propeller caused cavitation bubbles that in turn damaged the metal substrate after imploding onto the surface.

1. Aft view of the tanker
2. Surface preparation of the bronze propeller
3. Close up view of grinding profile
4. Finished application
