# BELZONA RESTORES THIS FAN PUMP TO LIKE NEW CONDITION

ID: 350

35,000 GPM Gould's Primary Fan Pump.

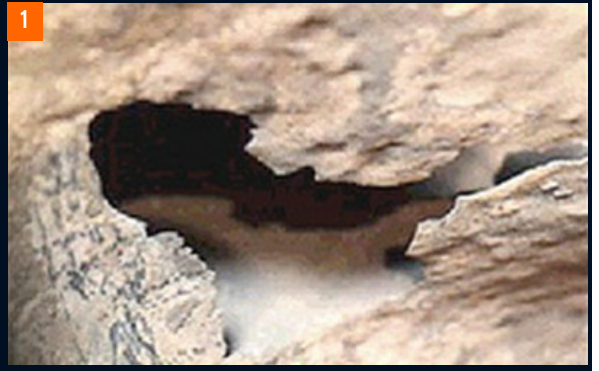
Extreme graphitization had caused holes between the suction and discharge sides of this fan pump after only four years of operation.

1. General view of casing showing graphitization and hole between suction and discharge sides
2. One half of the casing being rebuilt and resurfaced
3. Impeller in position to reform the case rings
