# CLASSIC BELZONA PUMP REFURBISHMENT-OUTPUT INCREASES 9.5% AFTER 3½ YEARS

ID: 363

Two badly corroded/cavitated centrifugal KSB water supply pumps.

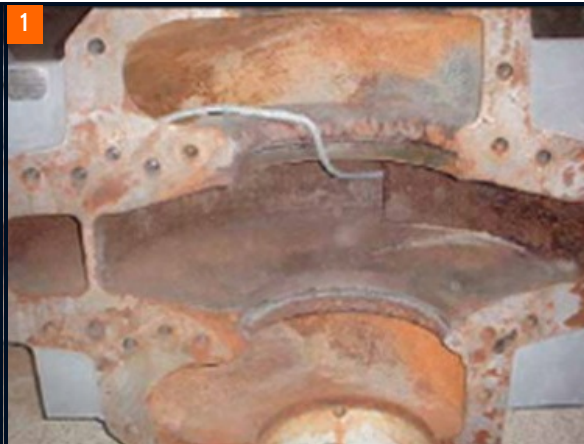
Output from the pumps was drastically reduced from the new condition due to corrosion and cavitation damage.

Damaged pump Neck ring seats restored to original sizes Complete repair Coating in good condition after 3-1/2 years of service
