# BELZONA REPAIRS AND PROTECTS ENGINE BLOCK AND CYLINDER LINERS

ID: 3641

Ship diesel engine block

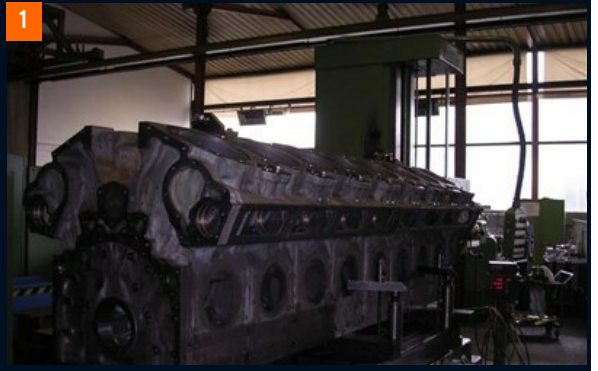
Corrosion and cavitation damage in cooling water area as well as leaking O-ring sealing surfaces.

1. Diesel engine block prior to repair
2. Close-up of application area
3. Close-up of application area
4. Completed engine block application

The repair to the sealing faces was carried out in accordance with Belzona Know-How System Leaflet ENC-5, using machining methods. Areas damaged by corrosion and cavitation were rebuilt with Belzona® 1111, and cooling water areas were fully coated with Belzona® 1391 in accordance with Belzona Know-How System Leaflet ENC-6.
