# BELZONA REPAIR TO OIL COOLER

ID: 366

Thrust bearing oil cooler from turbine

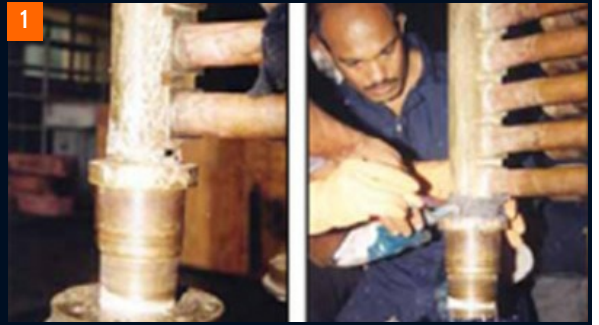
The unit was severely damaged and leaking as a result of bimetallic corrosion.

1. Corroded unit with holes clearly visible - Belzona 1111 being used to repair holed and corroded areas
2. Belzona 1321 being applied to protect unit
3. Completed application being pressure tested

Application was carried out using techniques adapted from Belzona System Leaflets HEX-3 & HEX-9. Holed and corroded areas were rebuilt using Belzona® 1111 incorporating Belzona® 9341 (Reinforcement Tape).

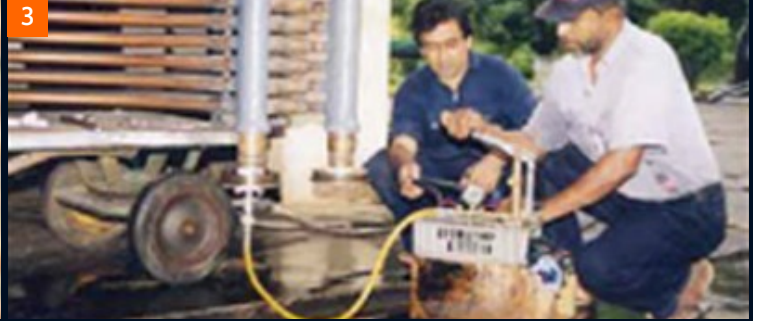
Unit was pressure tested before being returned to service and has regularly been inspected since and remains in perfect condition. Belzona repair was carried out at a fraction the cost of a replacement unit.
