# BELZONA REPAIRS DAMAGED RISER CLADDING

ID: 3719

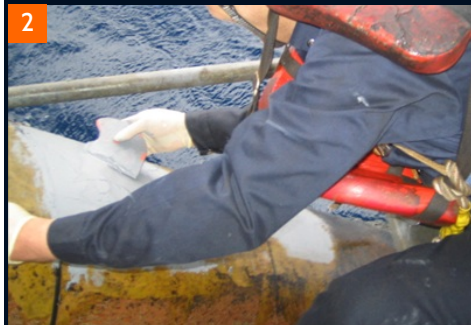
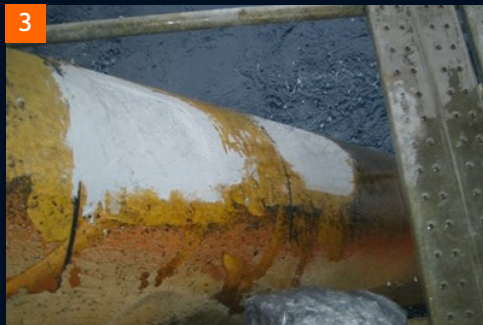
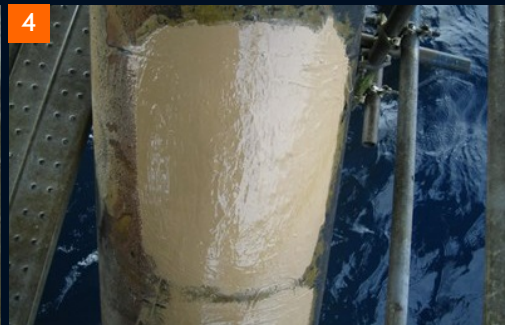
The riser cladding was damaged due to abrasion. This needed repairing before corrosion compromised the integrity of the riser.

1. Surface preparation with a disc grinder
2. Application of Belzona 1161
3. Cladding profile restored with Belzona 1161
4. Completed application after application of Belzona 5831

Application was carried out using a modified version of Belzona Know-How System Leaflet SOS-21. After surface preparation with a disc grinder, Belzona 1161 was used to rebuild the damaged area before overcoating with Belzona 5831 to protect the riser from further corrosion.
