# REBUILDING DAMAGED OVERHEAD CONCRETE

ID: 3823

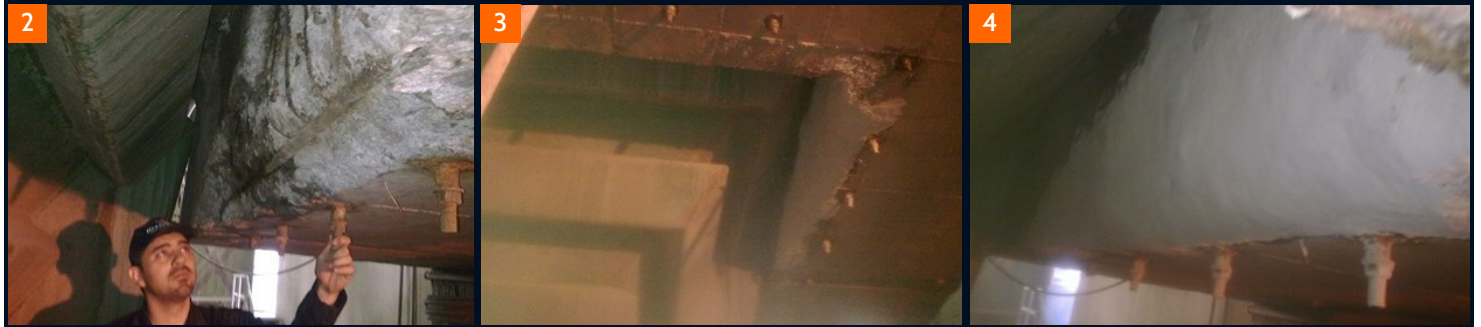
Due to the existence of crack in the concrete structure and ingress of water in the cracks, some area of concrete gets part and the round bars are corroded with expose to water and air.

1. Removing damaged concrete
2. Damaged area and showing round bars
3. and 4. Completed repair

Application carried out in accordance with the Belzona Know-How system leaflet RPA-2 and the selected Belzona 4141 mixed and applied in accordance with the relevant Instruction For Use. Overhead concrete structure has extensive areas of damage created by crack and water leakage and affects the round bars. Application of Belzona 4141 as a lightweight repair system, would protect round bar and reinforce the cracks.
