# BELZONA REPAIRS VENT GAS PIPEWORK

ID: 383

3" pipespool on gas platform vent system.

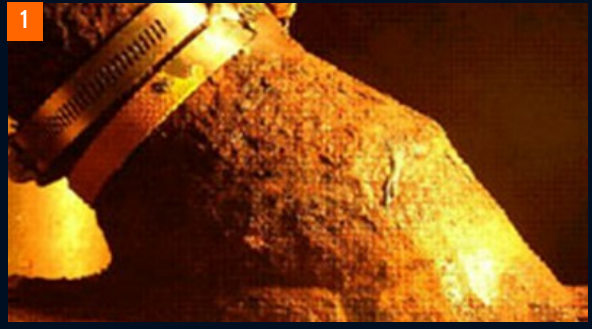
External corrosion had led to severe wall thinning in numerous parts of the pipework. In addition several areas were holed and were being contained with a temporary fix. The welded nature of the pipework would have made replacement of the pipespool impossible as the vent gas pipework forms part of the platform's safety system.

1. Vent gas pipework showing severe corrosion
2. Completed repair
3. Platform crane's radiator was the site of several other Belzona pipe repairs

During a recent platform shutdown the temporary repair was removed and the pipe and surrounding areas were cleaned by grit blasting. Belzona® 1111 was applied to the area and Belzona® 9341 wrapped around the pipe to prevent further deterioration of the corroded area.

This was pressure tested to the design pressure of the system before allowing gas back into the system. All tests were successfully completed.
