# BELZONA REPAIRS FUELING HOSES

ID: 39

Bunkering (fueling) hoses

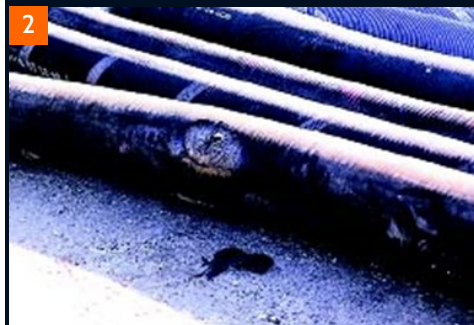
Bunkering hose outer skin damaged, potentially weakening the hose. A rupture could be catastrophic in terms of the environment and safety.

1. Damaged section removed
2. Damaged area after conditioning
3. Applying Belzona 2211 (MP Hi-Build Elastomer)
4. Finished application is ready for service

Application was carried out in accordance with Belzona Know-How Leaflet SOS-12.
