# CUSTOMER GOES NUTS OVER BELZONA FLOOR REPAIRS

ID: 394

## PROBLEM

Epoxy overlay of concrete floor in processing plant was disbonded in many places.

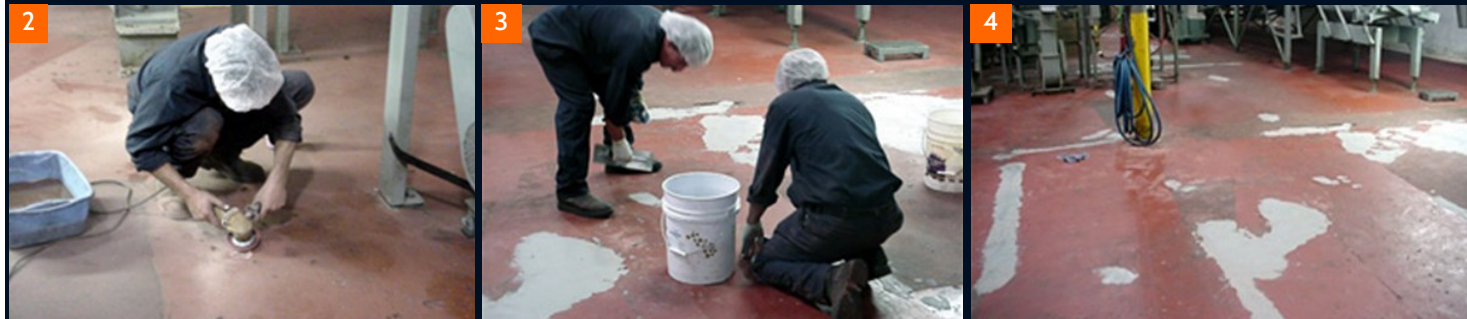
The floor was soaked with pecan oil making the application very difficult. A detergent wash was used on the floor followed by an odorless degreaser followed by mechanical abrasion. This was followed by another degreasing. The pecan factory was so pleased with these initial repairs that they purchased additional material and continue to address other floor problem areas as they arise. After several years all repairs are holding up very well.

1. Cleaning.
2. Surface preparation.
3. Application.
4. Finished.

The application was carried out in accordance with Belzona Know-How System Leaflet FPA-1.
