# BELZONA SEALS LEAKING CABLE END BUSHINGS

ID: 3945

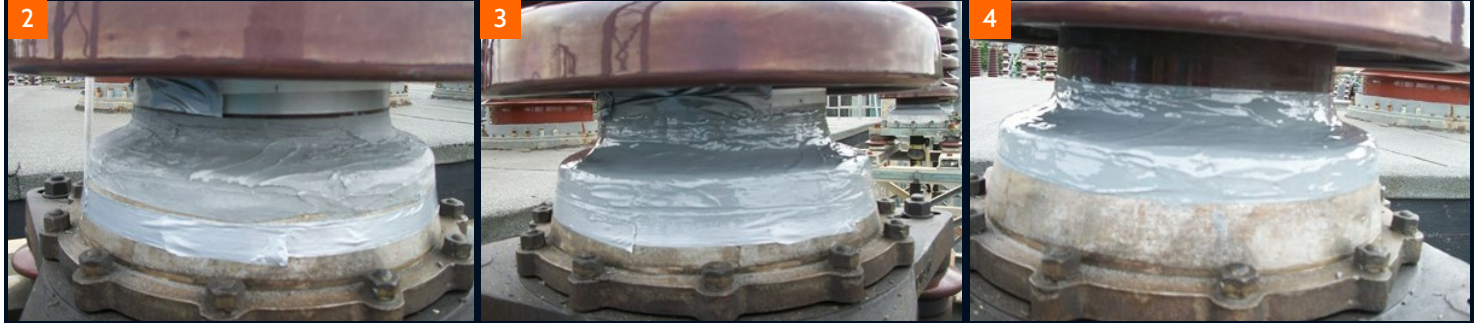
The red phase bushing was leaking oil and the uncontrolled release required sealing. The equipment is aged and the porcelain shed appeared to be fragile and brittle. The Client opted for competitively priced repair as opposed to high cost replacement with a view to extending the asset life.

Cement Joint between porcelain and steel flange disintegrated on three bushings - red, yellow and blue phases.

1. Original bushing condition
2. Repair area after applying Belzona 1291, Belzona 1221 & Belzona 1161
3. Final coating with Belzona 5831
4. Completed application

Application was carried out in accordance with Belzona Know-How System Leaflet VPF-11. After cleaning and abrading the substrate, Belzona® 1291 & Belzona® 1221 to stem leak between porcelain and steel joint before applying Belzona® 1161 including Reinforcement Tape. Finally Belzona® 5831 was applied to entire repair area.
