# BELZONA REPAIRS TO FLOATING HOSE

ID: 396

24" Yokohama floating hose.

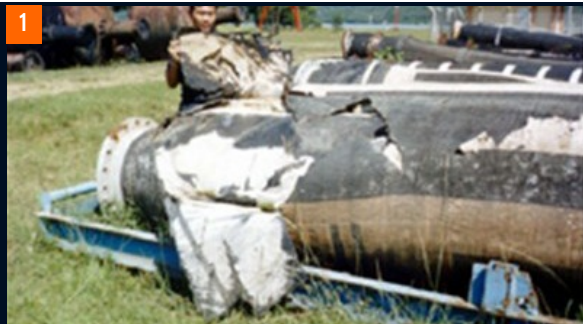
Extensive damage to the rubber flotation.

1. The extent of the damage clearly evident.
2. Application of Belzona 2221.
3. Completed application.
