# DAMAGED FENDER REFURBISHED USING BELZONA ELASTOMER

ID: 397

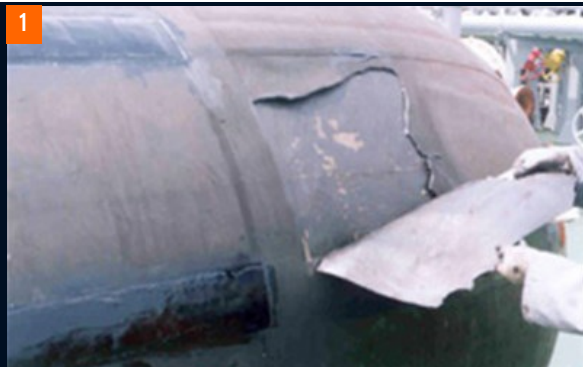
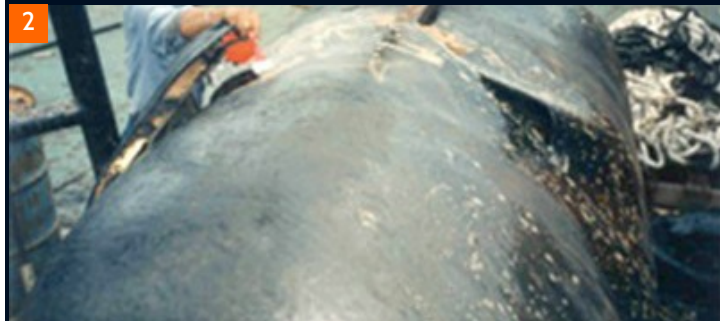
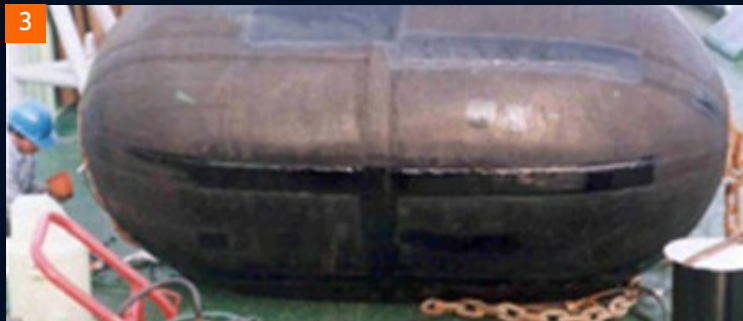
Severe damage to the surface of fenders. In particular securing chains had damaged the rubber covers through constant abrasion.

1. Damaged rubber being removed.
2. Application of Belzona Conditioner.
3. Completed application.

Application carried out in accordance with Belzona Know-How System Leaflet SOS-12.

Belzona 2211 (MP Hi-Build Elastomer)
