# BELZONA SEALS A TRANSFORMER LID FLANGE

ID: 3975

Lid gasket failure resulted in extensive oil leaks around flange on this 66-11Kv transformer.

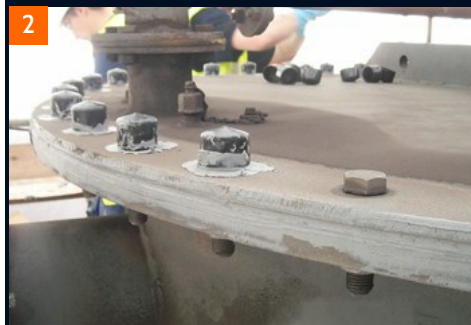
Most of the gasket had failed around the 10m perimeter of the lid, with oil seeping down the sides and going to ground. Unfortunately it was not possible to drain the oil below the gasket level and so the application had to be pursued as a live leak with a 1m head pressure.

1. Original condition of flange, with header tank at rear.
2. Encapsulation of bolts with Belzona 1161.
3. Completed repair close up.
4. Finished work after 3 days.
