# BELZONA RAPID ELASTOMER REPAIR TO CHOKE AND KILL HOSE

ID: 400

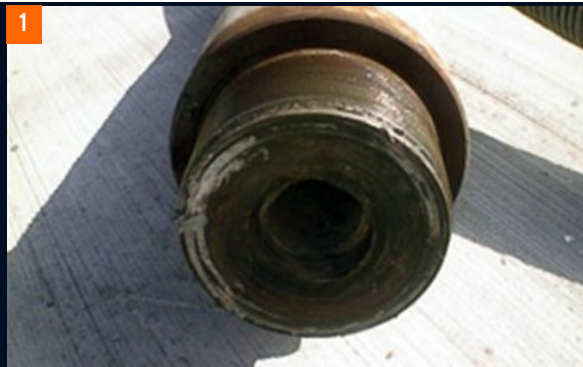
Damage had been caused to the rubber on the sealing face of the male hose connector, due to contact with sharp metal edges on the female connector. As a result of this a satisfactory seal was not being obtained and the customer was faced with returning them to the manufacturer for refurbishment.

1. Damage to the rubber lining on the male connector.
2. A new sealing face is produced using Belzona 2311.
3. The hose during pressure testing to 1300 bar.

The sealing face was manually prepared and the sealing face formed using an adaptation of Belzona Know-How System Leaflet GSS-1.

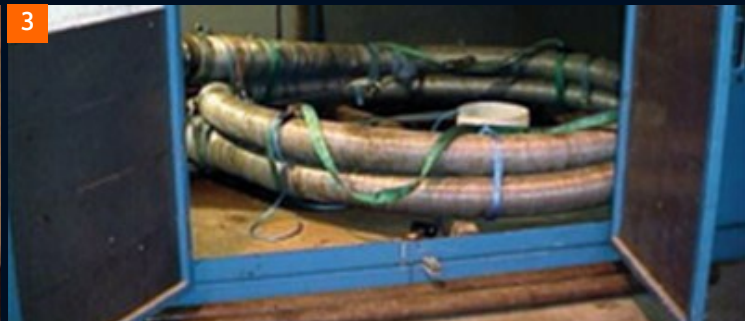
As the customer was faced with returning the hoses to the manufacturer, the use of Belzona® 2311 resulted in a significant cost saving, as well as ensuring that the units were returned to service as quickly as possible. The Belzona® 2311 repair was subjected to pressure testing prior to the hoses being returned to service and was successfully completed at 1300 bar.
