# BELZONA REPAIRS BALL MILL SHELL

ID: 4025

Ball mill shell damaged beneath wear plates.

Cement plant, Al Kawmeya, Egypt

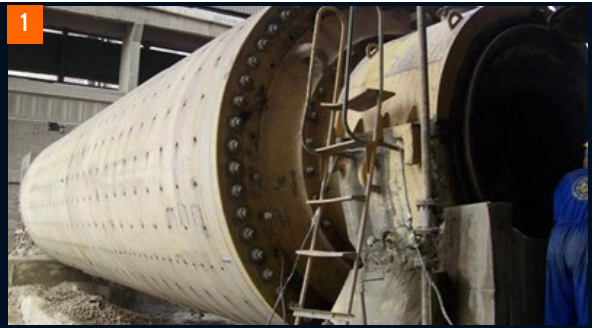
Due to the nature of the operation, the internal surfaces of the ball mill are subject to constant impact from the falling balls and other media present inside. Shell wall became damaged beneath the wear plates.

1. Damaged ball mill
2. Impact damage
3. Surface after preparation
4. Completed application
