# BELZONA REPAIR TO STONE CRUSHER SHAFT

ID: 409

Shaft of stone crusher.

Cement plant in Bulgaria

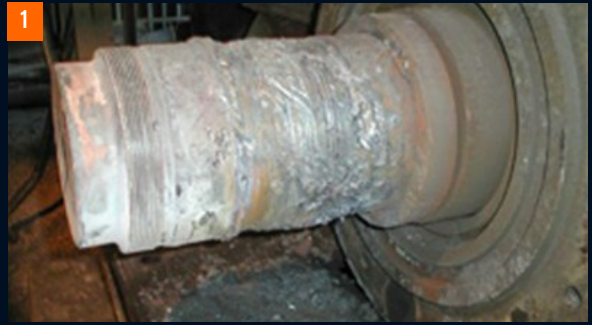
Severe wear on these 230mm diameter shafts caused by extreme loads, vibration and abrasion from dust leads to bearing failure.

1. Severely damaged shaft
2. Former in place and Belzona 1321 injected
3. Former removed and ready for re-assembly of bearing
