# BELZONA KEEPS HEAVY MACHINERY ON TRACK

ID: 41

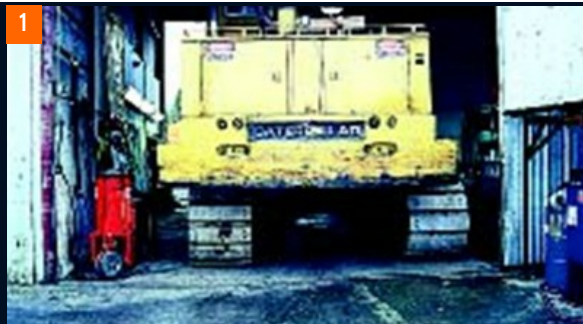
Track pad bolts were breaking due to excessive wear on rail and pad bolt fit. Excessive bolt replacement costs.

1. Cat 245 grapple
2. Rail surface preparation
3. Work in progress
4. Finished product
