# LEAKY CYLINDER SEATS REFURBISHED WITH BELZONA

ID: 415

Ship's engine cylinder seats.

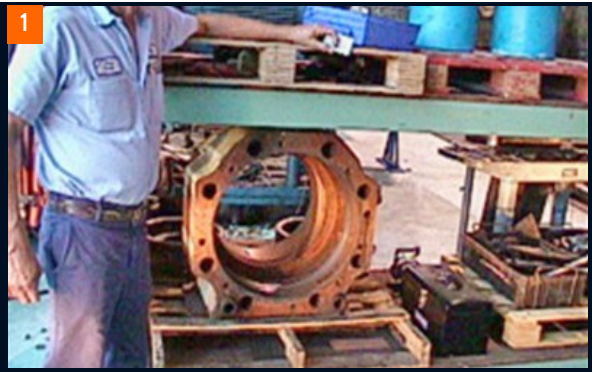
Significant cavitation and general corrosion from cooling water and fretting wear at O-ring seats.

1. Units as received from ship
2. Pitting corrosion in water jacket area
3. Prepared, coated and protected water jacket
4. Ready for service
