# BELZONA REPAIRS CRACKED GEARBOX

ID: 4219

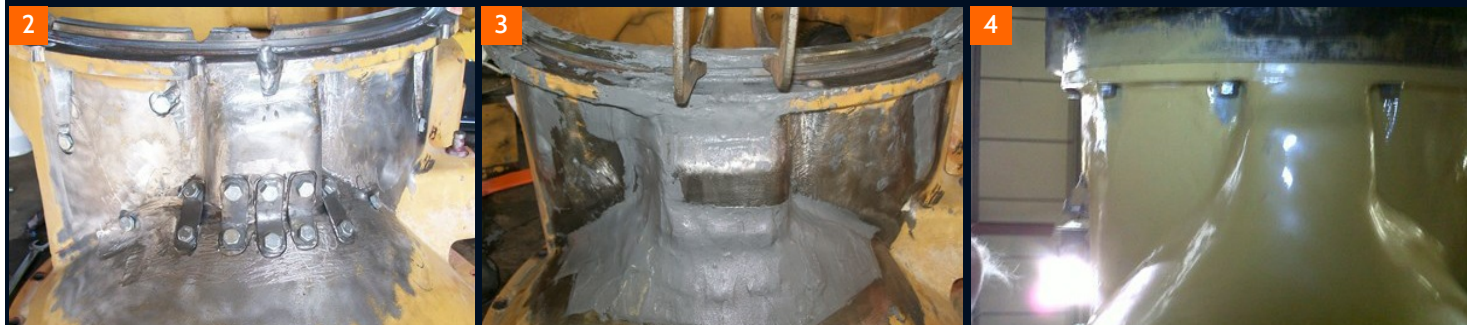
The workshop tried to repair this crack by welding it but when the weld cooled down the crack reopened and also created more cracks in the gearbox casing. Quarry contacted Belzona for an alternative solution.

Gearbox from CAT 966G loader was dropped from crane during routine maintenance causing large crack.

Cracks in gearbox marked in red  
Gearbox prepared by workshop Belzona 1111 being applied Completed repair with gearbox repainted and fitted to engine 2 days later

Application was carried out in accordance with Belzona Know-How System Leaflet ENC-1. After drilling and tapping ends of all cracks to "blind" them steel straps were bolted across the vee'd out cracks before sealing with Belzona® 1111 incorporating Belzona® 9341 (Reinforcement Tape). Finally the repair was smoothed and painted.
