# BELZONE EFFECTS EMERGENCY REPAIRS TO LEAKING SWIMMING POOL

ID: 4248

Public swimming pool, British Columbia, Canada

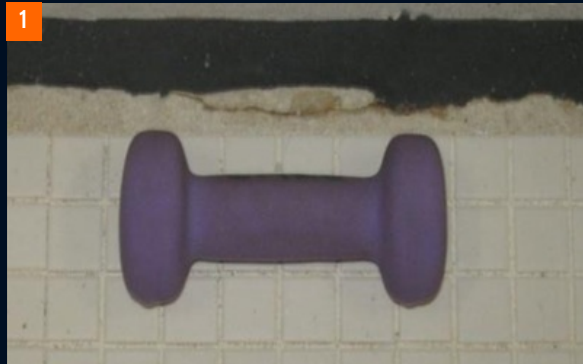
Vibration from the use of a “jackhammer “ by a contractor in the pool basin to expose leaking pipes had caused cracks to develop in the concrete grout forming the edges of this pool’s unique expansion joint system. Dye testing located 12 separate leaks.

1. The grout used to form the expansion joint sides, and the crack in it, are visible above the hand weight used to mark leak locations during dye testing
2. The void beneath the crack is exposed
3. The joint repaired. Twelve separate leaks were isolated and sealed
