# BELZONA REPAIRS PLATFORM'S SUMP PIPE

ID: 4271

Sump pipe at an oil and gas platform.

Oil and Gas Platform, Rio Grande do Norte, Brazil

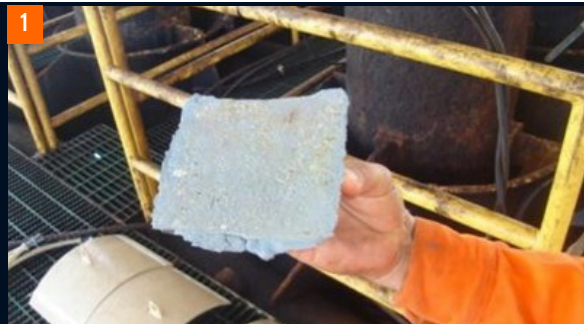
1. Adhesion test being carried out with plates coated with Belzona 5811 prior to application.
2. Testing Belzona 1161 on edges of plate under immersed conditions.
3. Application being carried out by divers under water.

Surface was cleaned in accordance with ISO 8501-1 St2/3 using a pneumatic sander. Fouling was chiseled away from the metallic structure. Prior to commencement of the application several plates were coated with Belzona 5811/Belzona 5831 to prevent and protect these pieces from further corrosion. Theoretical and practical training was imparted to the divers responsible for applying the products under water. Belzona 1111 was applied onto the panels before submersion. The plates were installed from top to bottom. "U" clamps were used to exert pressure onto the plates and to remove excess material. Belzona 1161 was then used to fill any gaps and to seal the ends of the plates. Upon completion, inspection was carried out and a small leak was detected. The leak was repaired with the Belzona 1161/Belzona 5831 system.

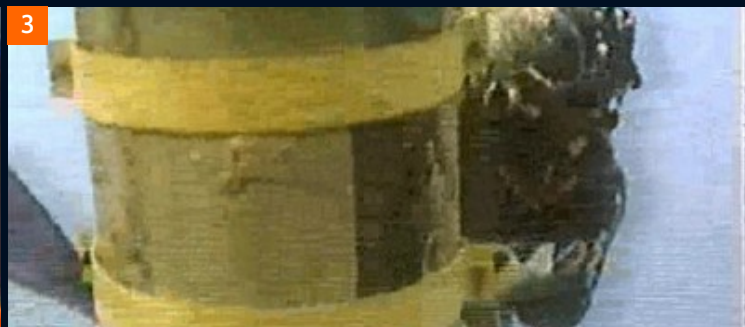
The sump pipe was cracked along its structure due to impact. It was required to seal the affected area using surface tolerant products that could also be used under water.
