# SERVICE LIFE OF DREDGING FLUSH WATER PUMP EXTENDED WITH BELZONA

ID: 4287

Rubber-lined KSB flush water pump on North Sea dredger.

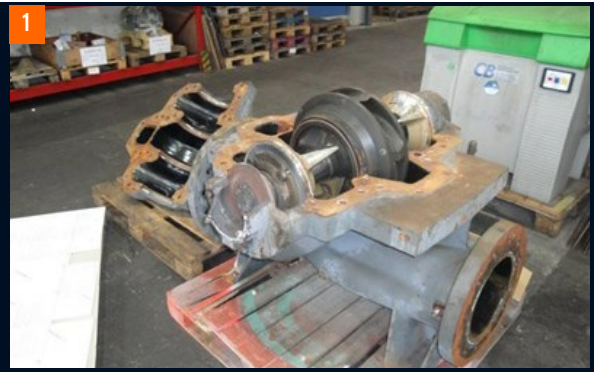
Extensive cavitation damage near impeller and high pressure areas. Cavitation and erosion had led to the pump casing's rubber lining being partly eroded. Further erosion damage was found on the casing.

1. Damaged rubber-lined pump
2. Close-up of one of the damaged areas
3. Damage rebuilt with Belzona 1812
4. Completed application with Belzona 2141 Elastomer applied
