# THERE'S NOTHING FISHY ABOUT THIS BELZONA REPAIR

Cracked engine block

Fishing boat

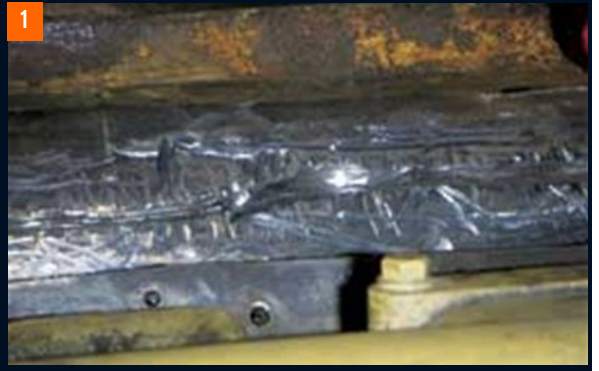
Cooling water froze due to lack of anti-freeze causing the engine block to crack.

1. Engine block after surface prep.
2. Belzona 1111 applied. Metal bars are used to stabilize crack.
3. Installing metal bars.
4. More Belzona 1111 applied to cover and protect the metal bars. Job completed.

The application was carried out in accordance with Belzona Know-How System Leaflet ENC-1.

Weld repairs were rejected due to concerns about heat stress. Quick turn around was important due to lost production while boat was in port.
