# LONG LASTING BELZONA STEP REPAIR - EXCELLENT AFTER 20 YEARS

ID: 431

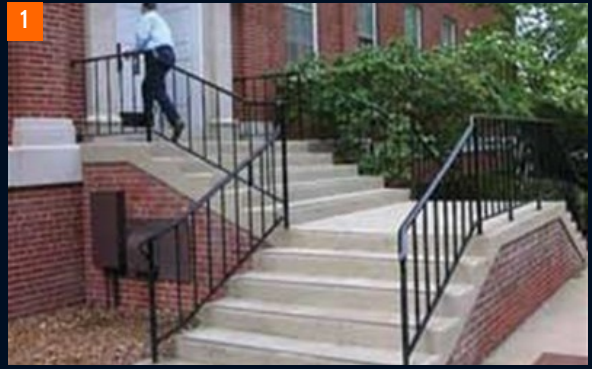
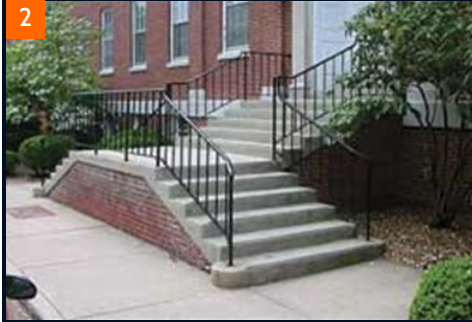
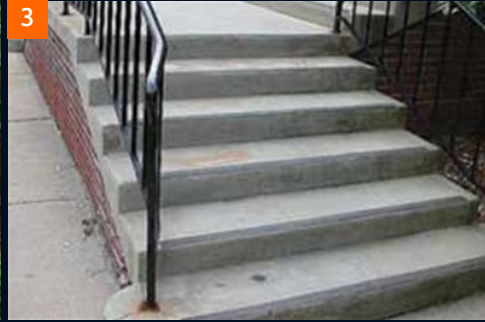
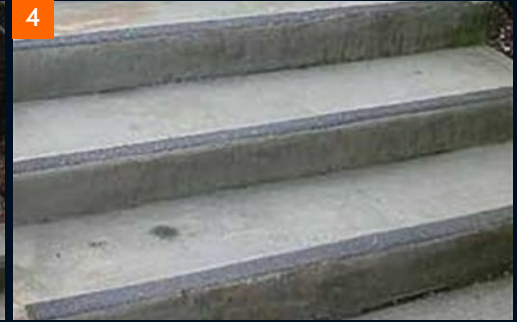
All the steps and landings were rebuilt/coated with 1/4" of Belzona® 4111. Strips of Belzona® (Ceramic S-Metal) and coarse aggregate were applied for safety. Repouring of the steps would have been very expensive and most likely would have suffered the same problem after a period of time. After 20 years the steps and the non-skid are still in excellent condition. The photos were taken in April of 2004.

1. to 4. Various angles of the steps.
