# BELZONA REPAIRS CONVEYOR DRIVE SHAFT IN-SITU

ID: 448

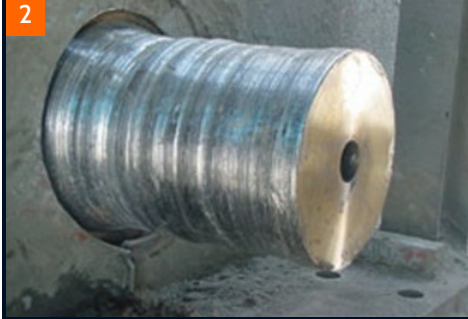
Drive shaft was badly worn due to incorrect tightening of the adjustable sleeve which leads to relative motion between the shaft and the sleeve.

1. General view of the elevator lifting clinker into silos
2. Damage to the shaft
3. Former in place and Belzona 1311 being injected
4. Accurate diameter restored to the shaft

Belzona® 1311 was injected, using pneumatic injection pistol, into former constructed to restore correct shaft diameter. The Belzona repair was carried out without need to remove shaft from the plant saving many days work.
