# BELZONA FLANGE REPAIR SYSTEM ON OFFSHORE PROCESS VESSEL

ID: 457

Nozzle flange faces on offshore degasser vessel

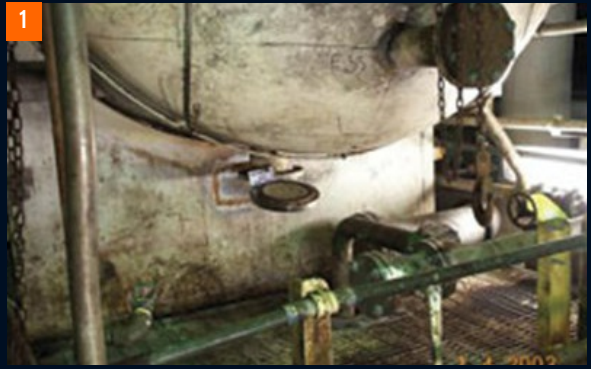
1. Offshore degasser vessel
2. Flange prior to refurbishment showing failed glass flake coating
3. Following refurbishment with Belzona 1111

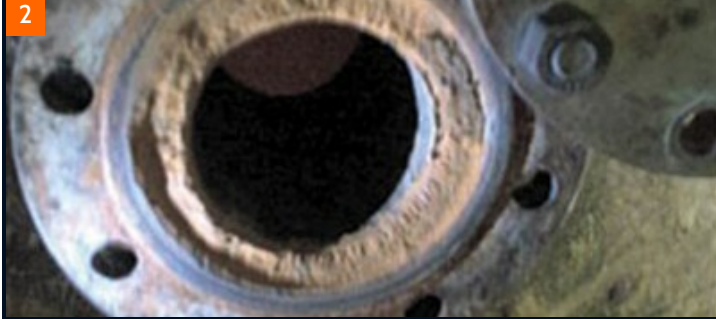
Failure of the glass flake lining material on the flange face had led to severe corrosion on 11 nozzle flange faces.

The flange faces were then reformed using equivalent weldneck flanges in accordance with Belzona Know-How System Leaflet VPF-13.
