# BELZONA SEALS LEAKING CABLE END BUSHING

ID: 4646

Electricity substation, UK

MAY 2013

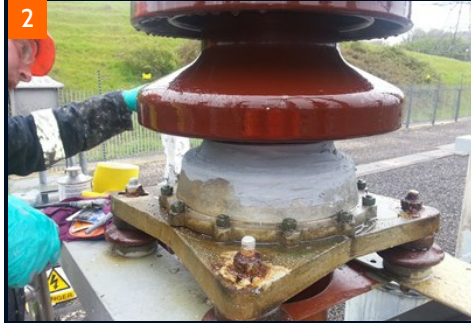
The yellow phase bushing was leaking oil and the uncontrolled release required sealing to allow further planned maintenance of other transformers in the substation to be carried out. The Client opted for a fast in situ repair as opposed to the possible long lead time of replacement and time required for installation which would cause further disruption to the planned maintenance schedule.

Cement joint between porcelain and steel flange had broken down on bushing - Yellow Phase

Original bushing condition. During the application of Belzona 1291, Belzona 1221 & Belzona 1161. Application of the Belzona 5831. Completed application.
