# BELZONA REPAIRS HYDROCARBON TRANSFER LINES ONLINE

ID: 4670

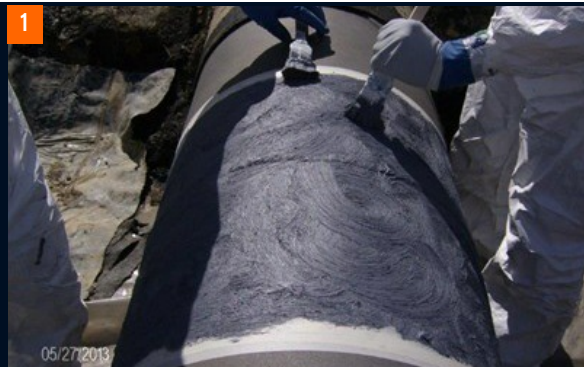
1. Wetting out the substrate 2. Rebuilding corrosion pitting 3. Applying the fibre/resin composite 4 Completed application

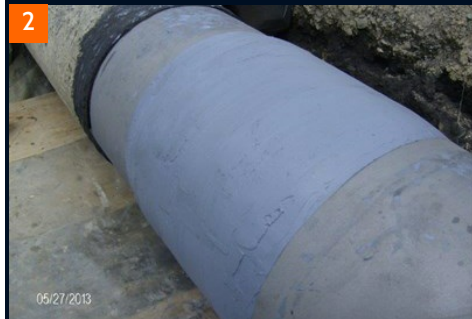
The pipelines were suffering from external corrosion, which had led to thin walls with minimum thickness in some places reaching 1.4mm, whereas the original wall thickness was 9.52mm. The client required a composite repair compliant to ISO/TS 2481 that could be completed on both pipes within a limited timeframe and without the need for shutdown.
