# BELZONA REPAIRS BROKEN HYDRO ELECTRIC TURBINE RUNNER

ID: 4674

Hydro Electric Plant, USA

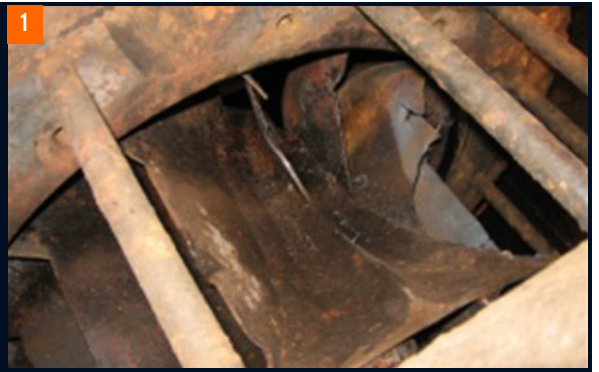
Wicket gate came loose and fell into turbine breaking three blades on runner.

Broken runner blade Expanded metal tack welded Blades rebuilt with Belzona 1311 Completed application after coating runner
