# RUBBER TRACKS ON MOBILE DRILLING RIG QUICKLY REPAIRED WITH BELZONA

ID: 4683

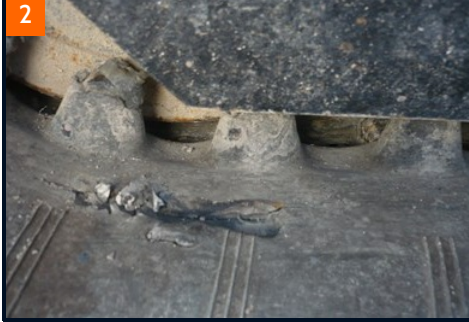
Several damaged areas on its rubberized tracks required quick repair to prevent track failure.

1. Geo drilling machine on site
2. One of the damaged areas on the tracks
3. Damaged area after surface preparation and Conditioning
4. Application finished.

Belzona 2311 (SR Elastomer)
