# BELZONA PROVIDES NEW LIFE FOR A BRICK FACTORY BELT

ID: 4700

Primary conveyor delivering clay into the building from the quarry.

Brick factory, Kent, England.

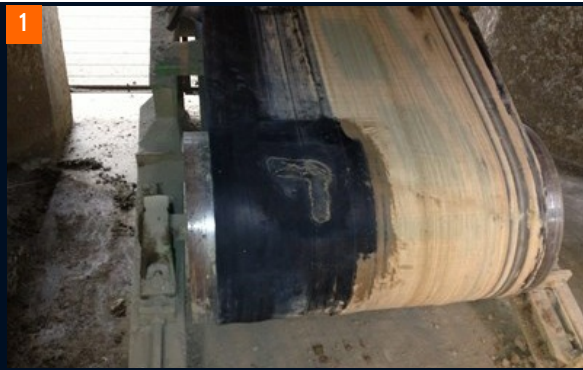
After years of use the belt had developed a tear and clay was penetrating the layers in the belt, if the belt was to deteriorate further the factory would need to employ an unplanned shutdown.

1. Damaged belt prior to repair
2. Cleaned and prepared with Belzona Roughing brush
3. Belzona 2311 being applied incorporating Belzona 9341 (Reinforcement tape)
4. Belt repaired and ready for years more service
