# BELZONA TAKES A GOOD HAMMERING

ID: 4721

2,500 tonne forging press.

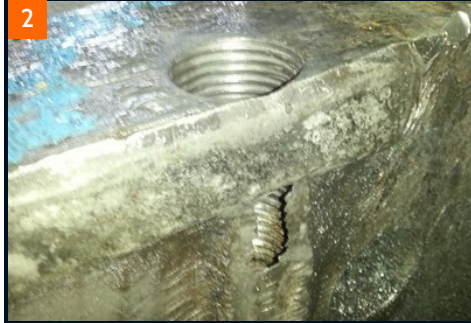
1. 2,500 tonne press in operation
2. Damage to base thread walls
3. Application of Belzona 1321 to wet out threads
4. All four bolts aligned with jigs whilst material cures

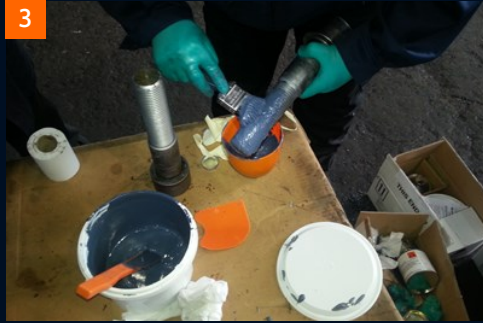
Lower bolster was not held securely due to loose fixing bolts. This led to misaligned die sets as the press hammered out parts. The movement was so severe that nearly 100% of production on this press was considered scrap and the company were considering a very expensive replacement. In addition it was found that the walls of the threads were holed and welding was impossible.

Application was then carried out in accordance with Belzona Know-How System Leaflet ENC-2 using Belzona® 1321 after first reparing holes in side of casting by bonding plates in place with Belzona® 1221.
