# BELZONA REINFLATES FENDER

ID: 4806

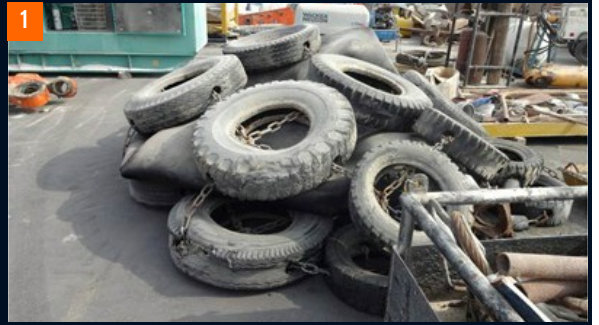
Although wrapped with tyres on chains to help protection, the fenders were in need of a full service or replacement. Punctures had deflated the fenders rendering them useless.

1. Initial inspection of deflated fender
2. Stitching of punctures
3. Application of Belzona 2111 incorporating
4. Reinforcement tape Finished application
