# BELZONA REPAIRS NEW FLOATING HOSE SECTION DAMAGED IN TRANSIT

ID: 4818

Damaged floating hose section

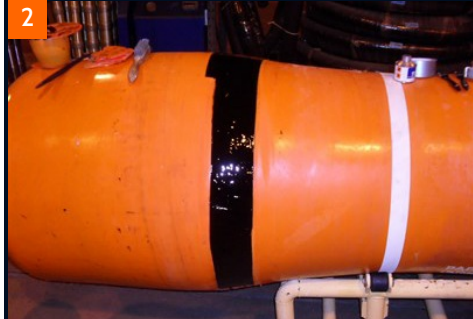
Hose had been damaged in transit as a result of its fastenings coming loose. The hose had rubbed against its container frame.

1. 15mm deep cuts in the floating hose cover 2. Application of reinforced system of Belzona 2211 3. Completed Belzona repair 4. Inspection of the hose 2 years later showing the Belzona application still in service

Application was carried out in accordance with Belzona System Leaflet SOS-12. The surface of the hose was roughened prior to application of Belzona 2911 (QD Conditioner) followed by a reinforced system of Belzona 2211 to the damaged areas.

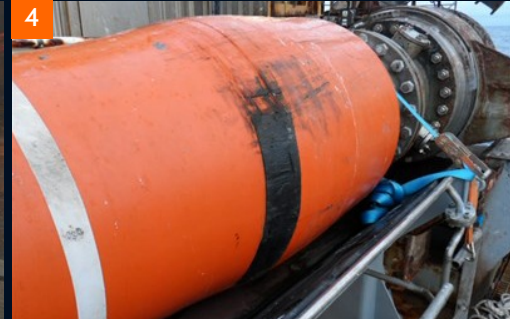
The application was completed at a fraction of the cost of a replacement hose and has proved to be successful for 2 years.
