# BELZONA REPAIRS HAZARDOUS OIL LEAK

ID: 4828

Two 19 inch diameter bushings on a transformer.

Power Station, Glasgow, UK

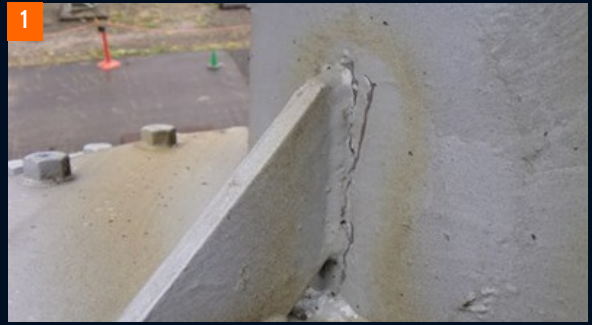
The two bushings were leaking oil. The leaks were coming from cracks in four steel support struts. These cracks were leaking oil and creating an environmental hazard.

1. View of one of the cracked struts
2. Bushing before application commenced
3. Completed application with plates bond in place
4. General view of the transformer after completing the repairs

Application was carried out in accordance with Belzona Know-How System Leaflets VPF-8 & VPF-11. The leaks were first stemmed using Belzona 1291. Pre blasted plates were then bonded into place around the struts, the purpose of these plates was to both seal the leaks and to give the structure back some strength so the cracks in the steel would not propagate. Belzona 5831 was applied to give overall corrosion protection to the repaired areas.
