# REPAIR OF MOTOR BLOCK OF 789 MINING TRUCK

ID: 4868

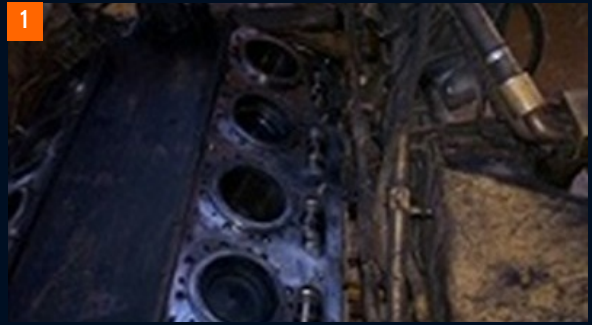
The engine was corroded and presented a problem in the filtration area where water flows from the engine block

1. Damaged engine block
2. Application of Belzona 1111
3. Engine block repaired with Belzona 1111
4. Repaired mining truck 789
