# BELZONA SETS ANCHOR AT THE GEARBOX BASE OF ROD MILL

ID: 4893

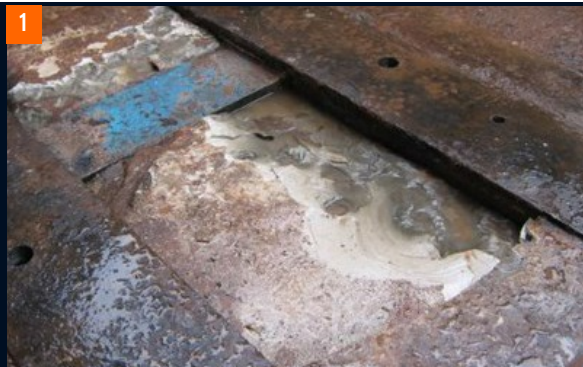
There was a need to install reinforcement at the anchoring of the concrete with base plate of the gearbox, with the addition of four extra intermediate anchors that could be set efficiently. Return to service needed to be as quick as possible as the damaged base was causing the equipment to break.

1. Damaged gearbox base causing excessive vibration
2. Base holes to anchor's housing
3. Anchors set according to template

There was a need to set intermediate anchors with a fast curing material with efficient anchorage on concrete base.
