# BELZONA REPAIRS THE BASE DRIVE OF A COKE MILL

ID: 4895

Base drive of the ball mill

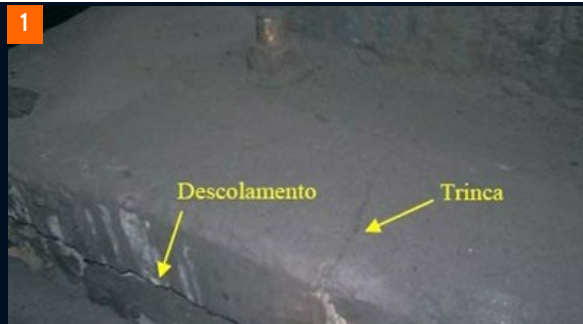
The leveling grout of the mill's base drive was crushed, cracked and had loss of a section. Because of that, the equipment lost partial support area, which increased the pressure on the horizontal and vertical load anchors. Consequently, anchors sheared over time, which increased the vibration of the equipment.

1. Drive base crushed, cracked and with loss of a section
2. Application of Belzona 4911 on all the surface of the base
3. Base completely recovered with Belzona 4111
4. Application of Belzona 4111 and Belzona 4151 by injection

This application was carried out based on the Belzona Know How System Leaflets FPA-10 and FPA-1. First, all existing grouting was removed. The base surface was prepared with industrial sander and, after cleaning, conditioned with Belzona 4911 and Belzona 4111 was applied. After preparation, the metal structure was installed on the base and leveled with shims and anchor bolts. Application of Belzona 4111 and Belzona 4151 followed by injection. Operation conditions: temperature 30 to 40°C – Dry Service.
