# BELZONA REPAIRS AND PROTECTS SX/EW TANKHOUSE CELL

ID: 4931

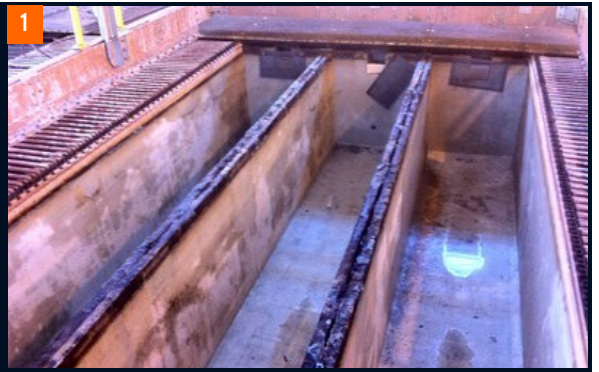
Polymer concrete SXEW process cells had been experiencing cracking which caused leakage of copper sulfate electrolyte solution. The furniture rails which suspend the copper anode plates were experiencing resin burnout from heat transfer through the cathodes.

1. Overview of the tankhouse cell
2. Furniture rails repaired with Belzona 4111
3. Tankhouse cell protected with Belzona 4341
4. Tankhouse cell protected with Belzona 4341
