# RUBBER LINER IN SLURRY PUMP REPAIRED WITH BELZONA

ID: 4935

Rubber lined Warman 10/8M slurry pump.

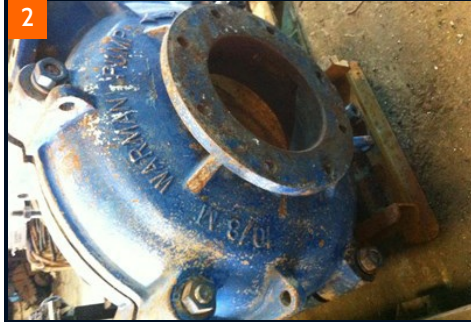
The rubber liner had suffered local damage resulting in an operational shutdown.

1. Damaged rubber liner
2. The Warman 10/8M pump
3. Damaged area Conditioned with Belzona 2911 (Elastomer QD Conditioner)
4. Rubber liner after application of Belzona 2311
