# BELZONA RESTORES DAMAGED CLUTCH ON DREDGER

ID: 4971

Dredger pumping gravel and water from the bottom of the lake

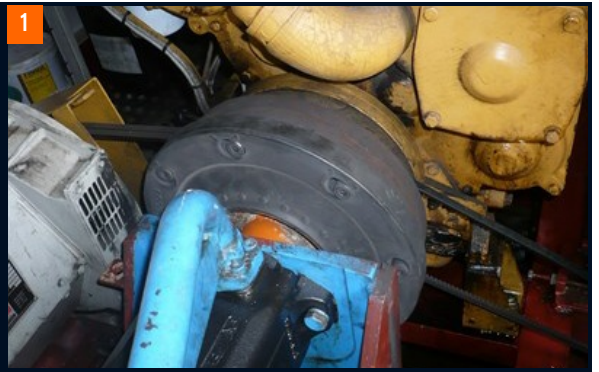
Rubberized clutch suffered damage during operation of the engine. The holes became deformed and the clutch was no longer performing as needed.

1. Damaged clutch in its original position
2. Metal plates treated with Belzona 9411 and fastened to seal one side of every hole
3. Filling previously prepared and conditioned holes with Belzona 2211
4. Application completed. Old holes sealed and new ones drilled
