# BELZONA REPAIRS CRUSHER'S ADJUSTMENT RING

ID: 5087

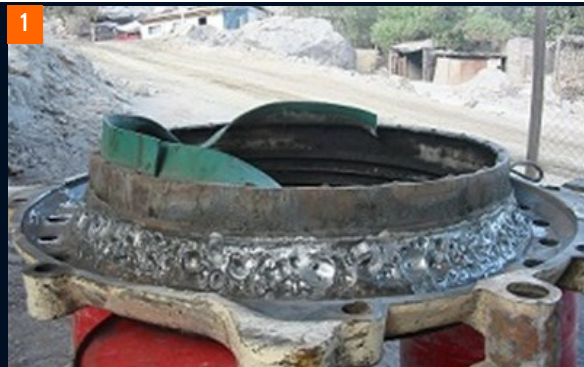
The worn-out strip prevented the crusher from functioning well.

1. Damage on the ring of the crusher
2. Application of Belzona 9411 on the surface of the crusher
3. Application of Belzona 1111 on the strip of the worn-out ring
4. The ring repaired with Belzona 1111
